Report on the investigation of a  
fatal accident during mooring operations  
on board the bulk carrier

***Mona Manx***

at Puerto Ventanas, Chile

on 26 August 2021

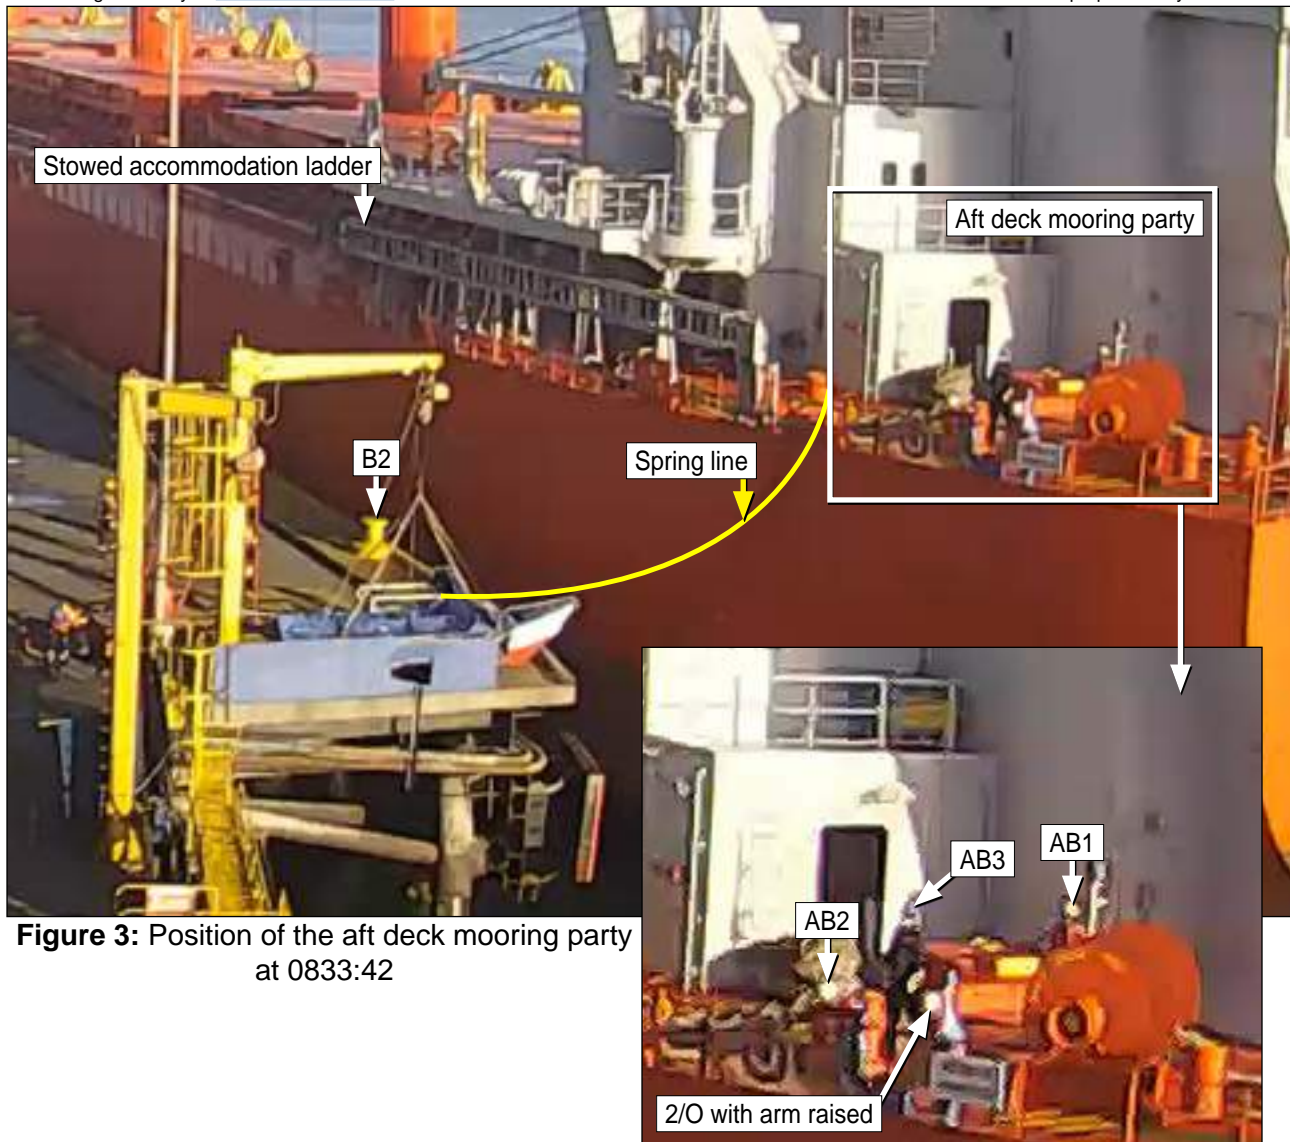
**Figure 3:** Position of the aft deck mooring party at 0833:42

At 0832:42, *Mona Manx's* engine control was set to *dead slow astern*, and the vessel began to move astern, eventually reaching a speed of 0.5 knots. During the manoeuvre, the forward mooring party heaved in the slack on the forward spring and the aft deck mooring party slackened down the aft spring (**Figure 3**).

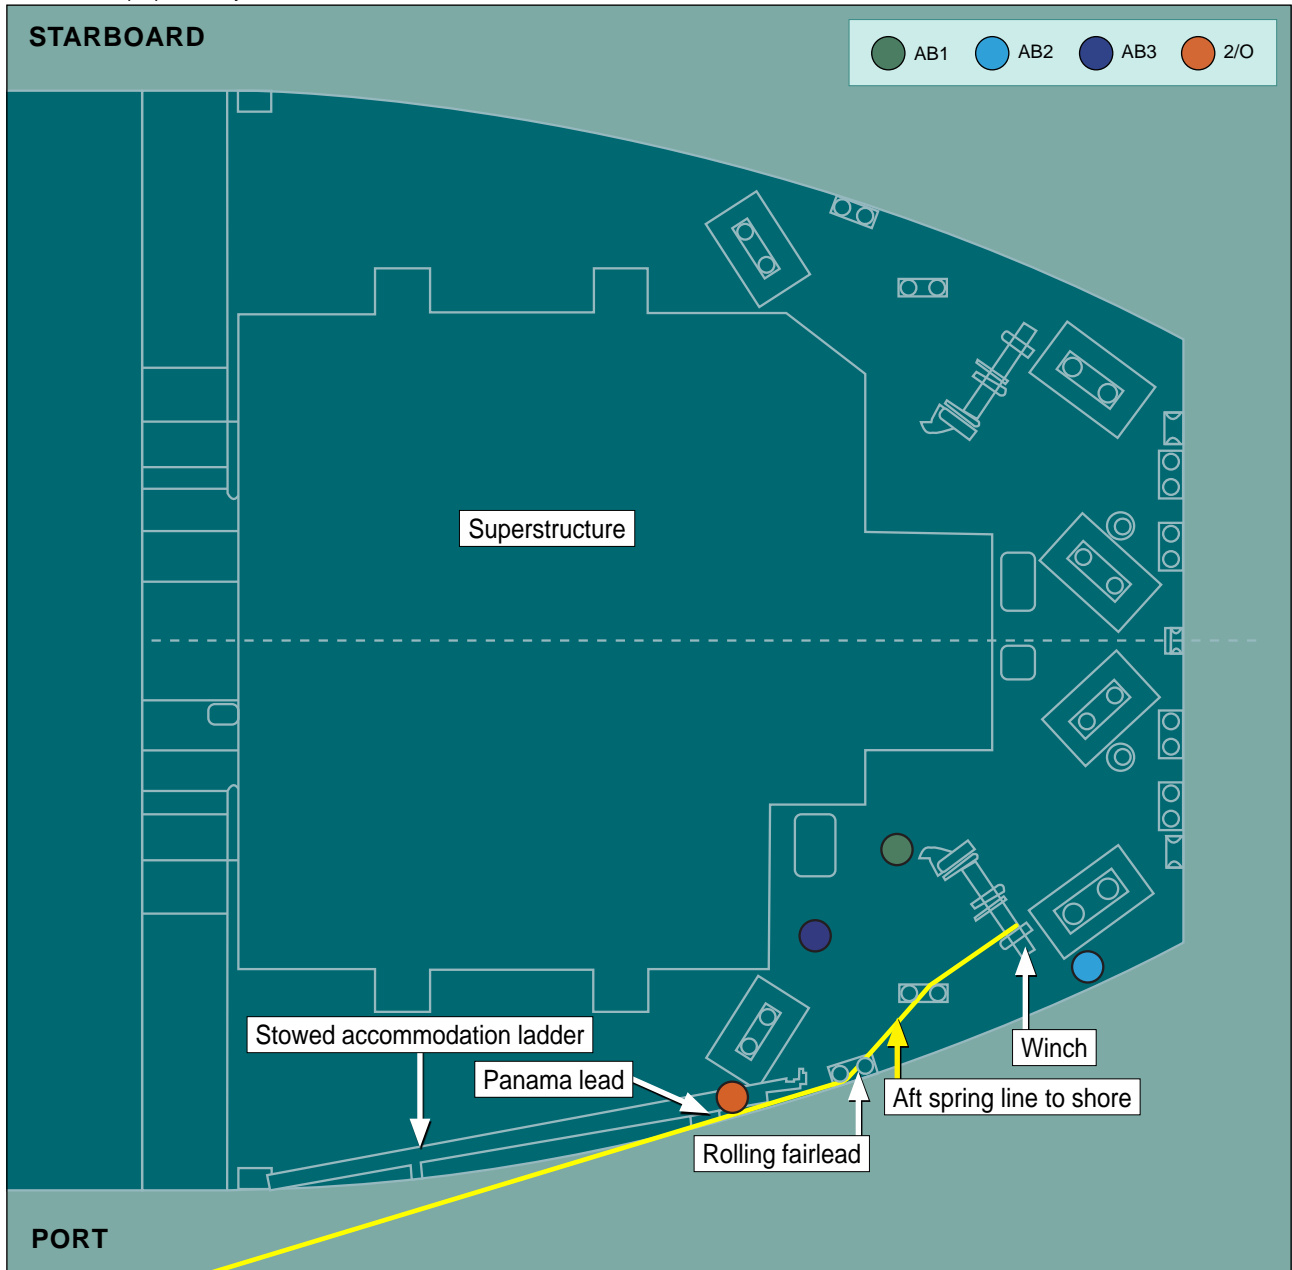
Figure 4: Position of the aft deck mooring party at 0836

At 0835:50, *Mona Manx* was almost in position and its engine control was set to *stop*. At the same time the 2/O moved forward to monitor the situation, stepping over the aft spring line on the mooring deck. As *Mona Manx* continued to move slowly astern the 2/O ducked under the stowed accommodation ladder to make his way forward to the Panama lead at the vessel's side, making a brief stop there at 0836 (**Figure 4**) before turning and moving forward again.

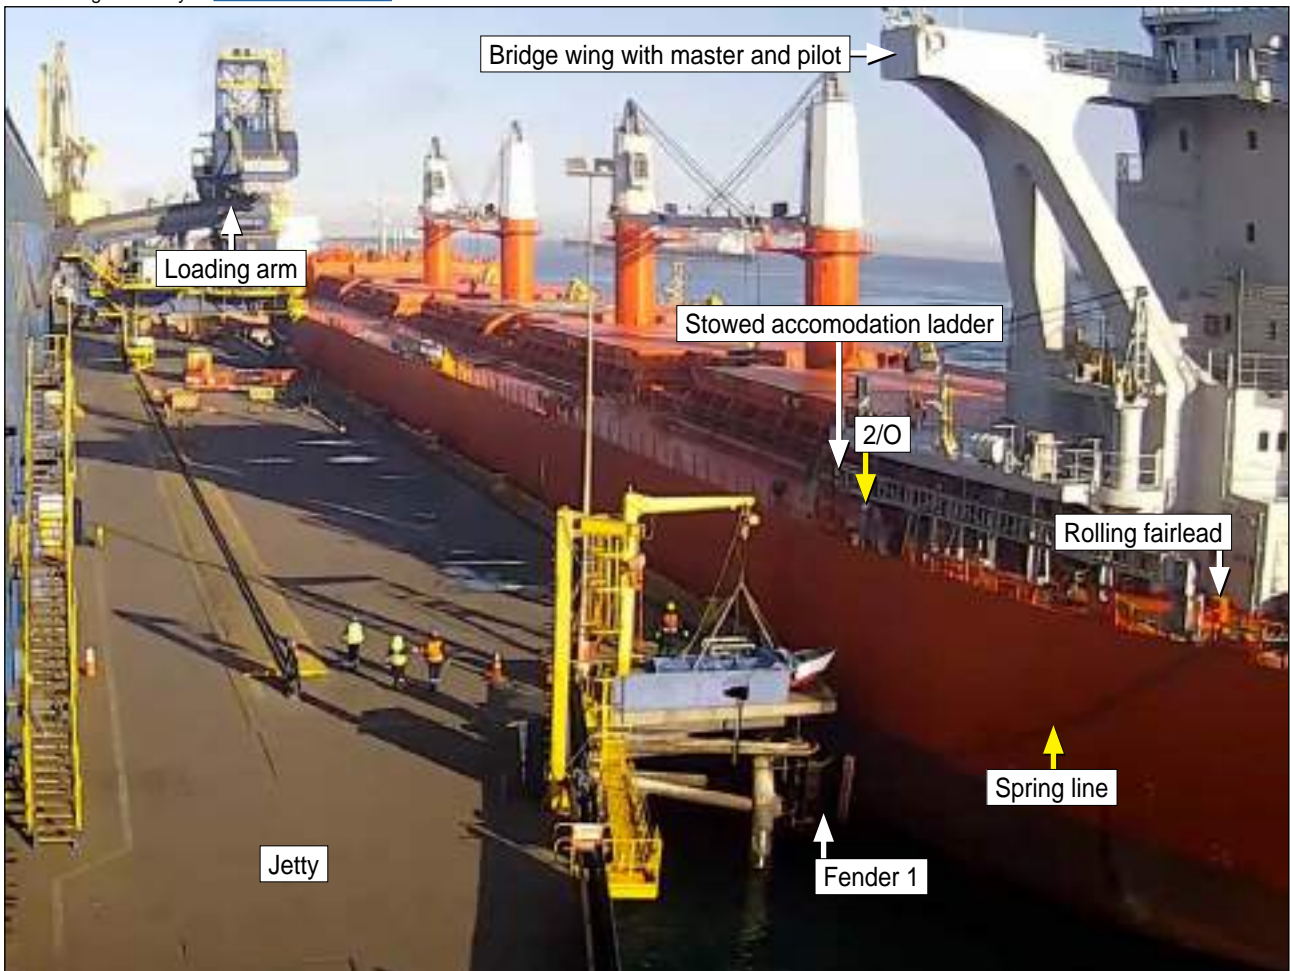
Figure 5: Position of the 2/O at 0836:11

At 0836:11, the 2/O arrived near the forward end of the accommodation ladder (**Figure 5**) and looked over the side rail directly above the slack spring line while using a very high frequency (VHF) radio (**Figure 6**). A few seconds later, the spring line tightened and then slackened. At 0836:23, the 2/O appeared to use the VHF radio again as the spring line came under tension once more.

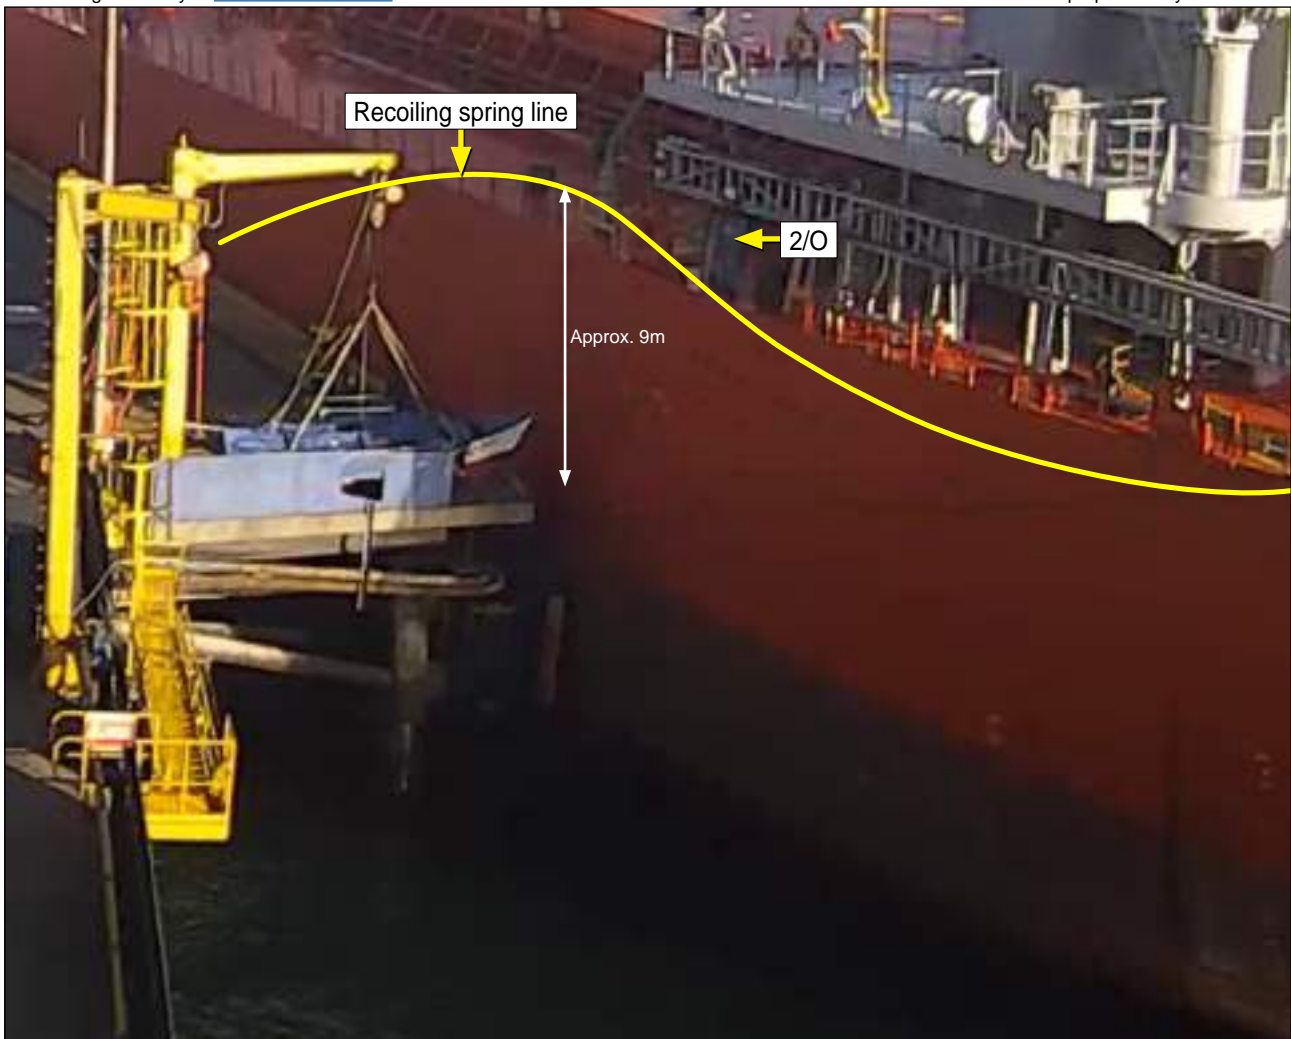
**Figure 7:** Aft spring line recoiling upwards at 0836:31

At 0836:31, a linesman on the quay was moving forward towards the tensioned spring line when a loud bang was heard as the line suddenly released and recoiled vertically upwards (**Figure 7**). The linesman quickly moved away but the spring line struck the 2/O under his chin and he was lifted off his feet and thrown backwards, causing his head to strike the accommodation ladder that was behind and above him. The force of the impact threw his safety helmet backwards, and his VHF radio was catapulted into the water as he collapsed onto the deck.

The working length of the spring line from the estimated point of entrapment to the aft rolling fairlead was about 29m. On its release, the spring line took less than one second to recoil approximately 9m upwards (see **Figure 7**) and strike the 2/O.

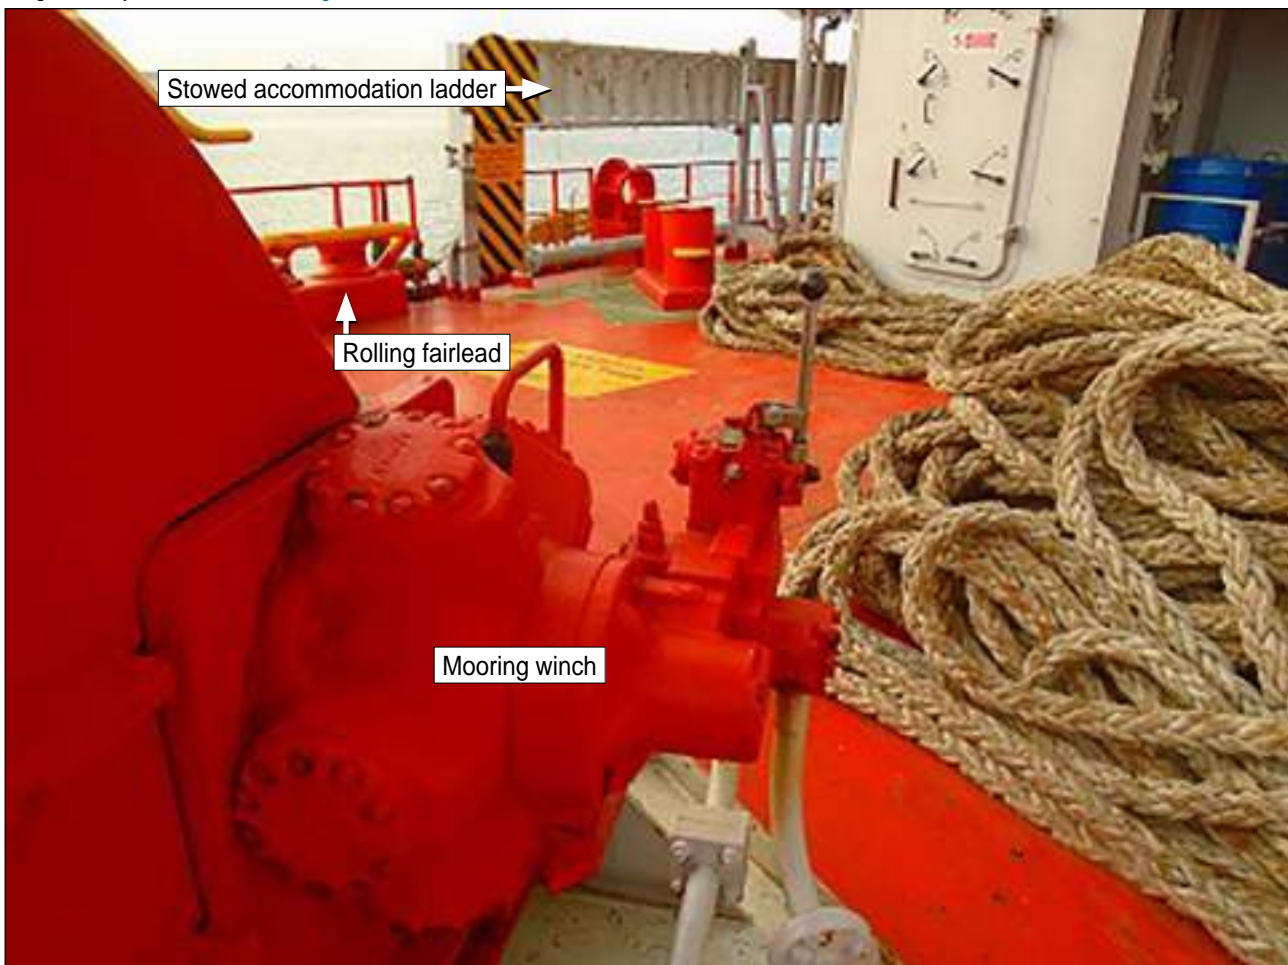
**Figure 8:** *Mona Manx*'s aft mooring deck (view to port forward)

The aft mooring deck equipment was arranged symmetrically, with the port and starboard side each comprising a single winch and a combination of mooring bitts, Panama leads and rolling fairleads. The port side winch was sited so that its operator would be facing outboard to port when standing directly behind the controls (**Figure 8**).

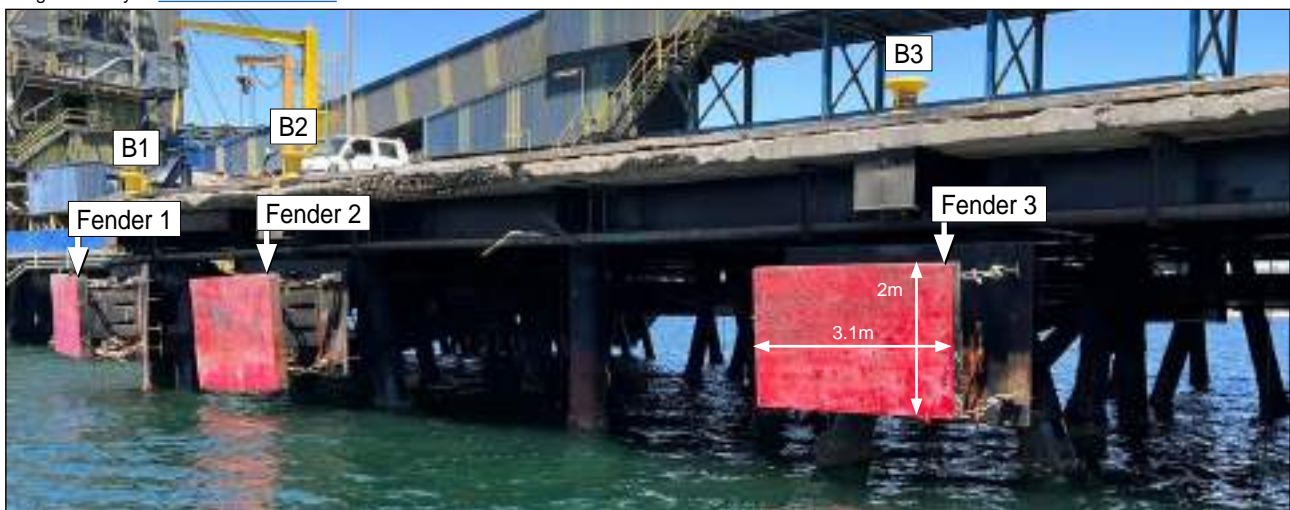
**Figure 9:** Fenders at Puerto Ventanas Site 3

Site 3 was located on the north face of the jetty and 13 rectangular fenders were fixed along its berth. Fitted in 1992, the fenders were constructed from rubber and steel and each one measured 3.1m wide and 2m high. The fenders were attached using flexible rubber mounts and chains and extended 1.2m from the face of the berth (**Figure 9**). At the time of the accident the sea surface level was about 3.28m below the jetty and the fenders were clear of the water.

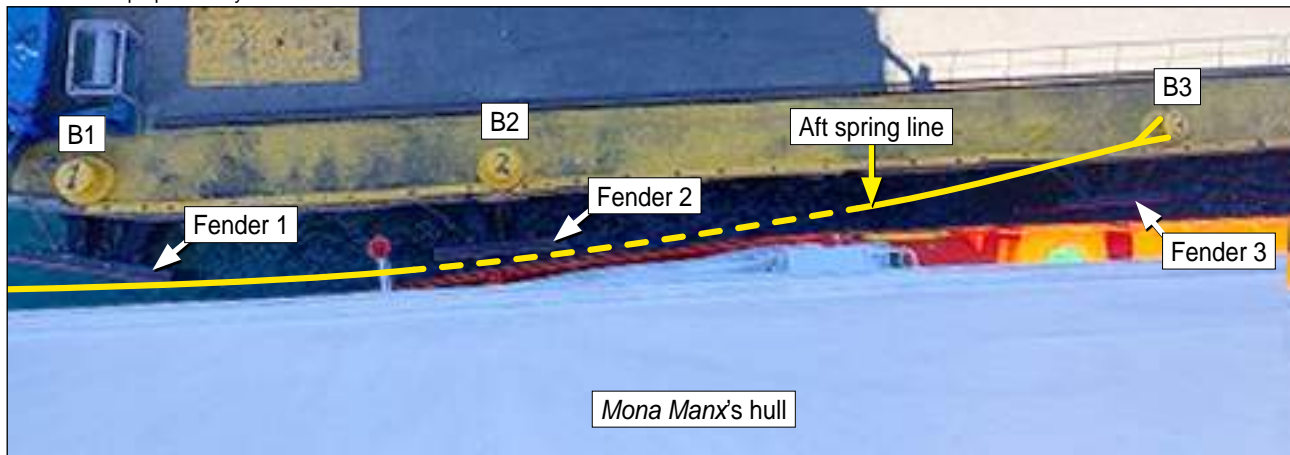
**Figure 10:** Representation of entrapment of aft spring line between *Mona Manx's* hull and the second fender

As *Mona Manx* moved astern it was necessary for the aft deck mooring party to slacken down the spring line and it is apparent that the line became entrapped during this operation, either under the fender or between *Mona Manx's* hull and the face of the fender (**Figure 10**). It is probable that as the vessel continued moving the line tensioned and *Mona Manx* momentarily moved away from the jetty, possibly due to the movement of the tugs' reducing thrust onto the vessel's side, allowing the bulk carrier to 'drift' off the fenders. The entrapped line released and the stored energy in the spring line caused it to displace upwards. The spring line deflected approximately 9m upward at an estimated speed of 18m per second, leaving the 2/O minimal opportunity to move out of its path.

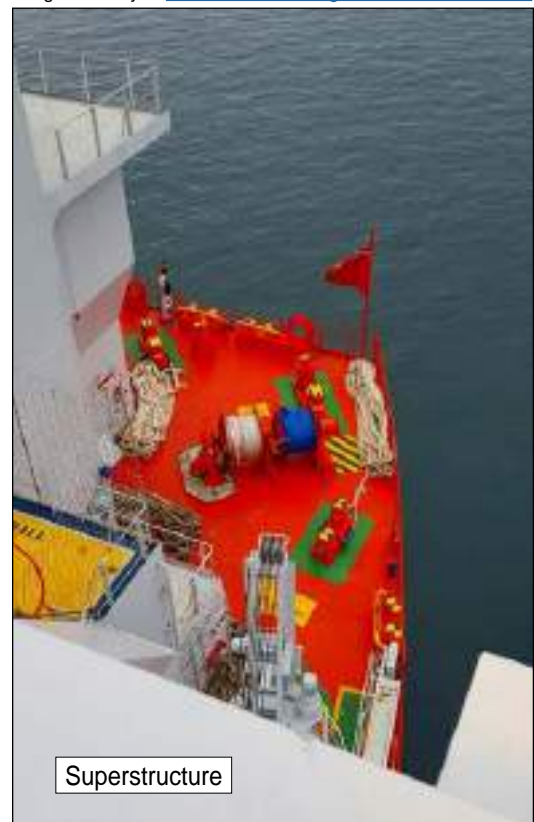
**Figure 11:** View of aft mooring deck from *Mona Manx*'s port bridge wing

The operation of moving *Mona Manx* alongside the berth using the vessel's engines and with mooring lines deployed was not included in either *Mona Manx*'s SMS or the terminal risk assessments. The requirement in the SMS that the crew only conduct a toolbox talk before attempting to warp the vessel meant a toolbox talk was not completed and the opportunity to identify the potential hazards of line entrapment and release was missed. Consequently, risk mitigations such as moving the loading arm to accommodate *Mona Manx* in its initial position rather than moving the vessel or recovering the mooring lines before manoeuvring were not considered.
