PTR HOLLAND® GROUP

**PILOT LADDER MAINTENANCE,
USE, REPLACEMENT
& INSPECTION RECORD BOOK**

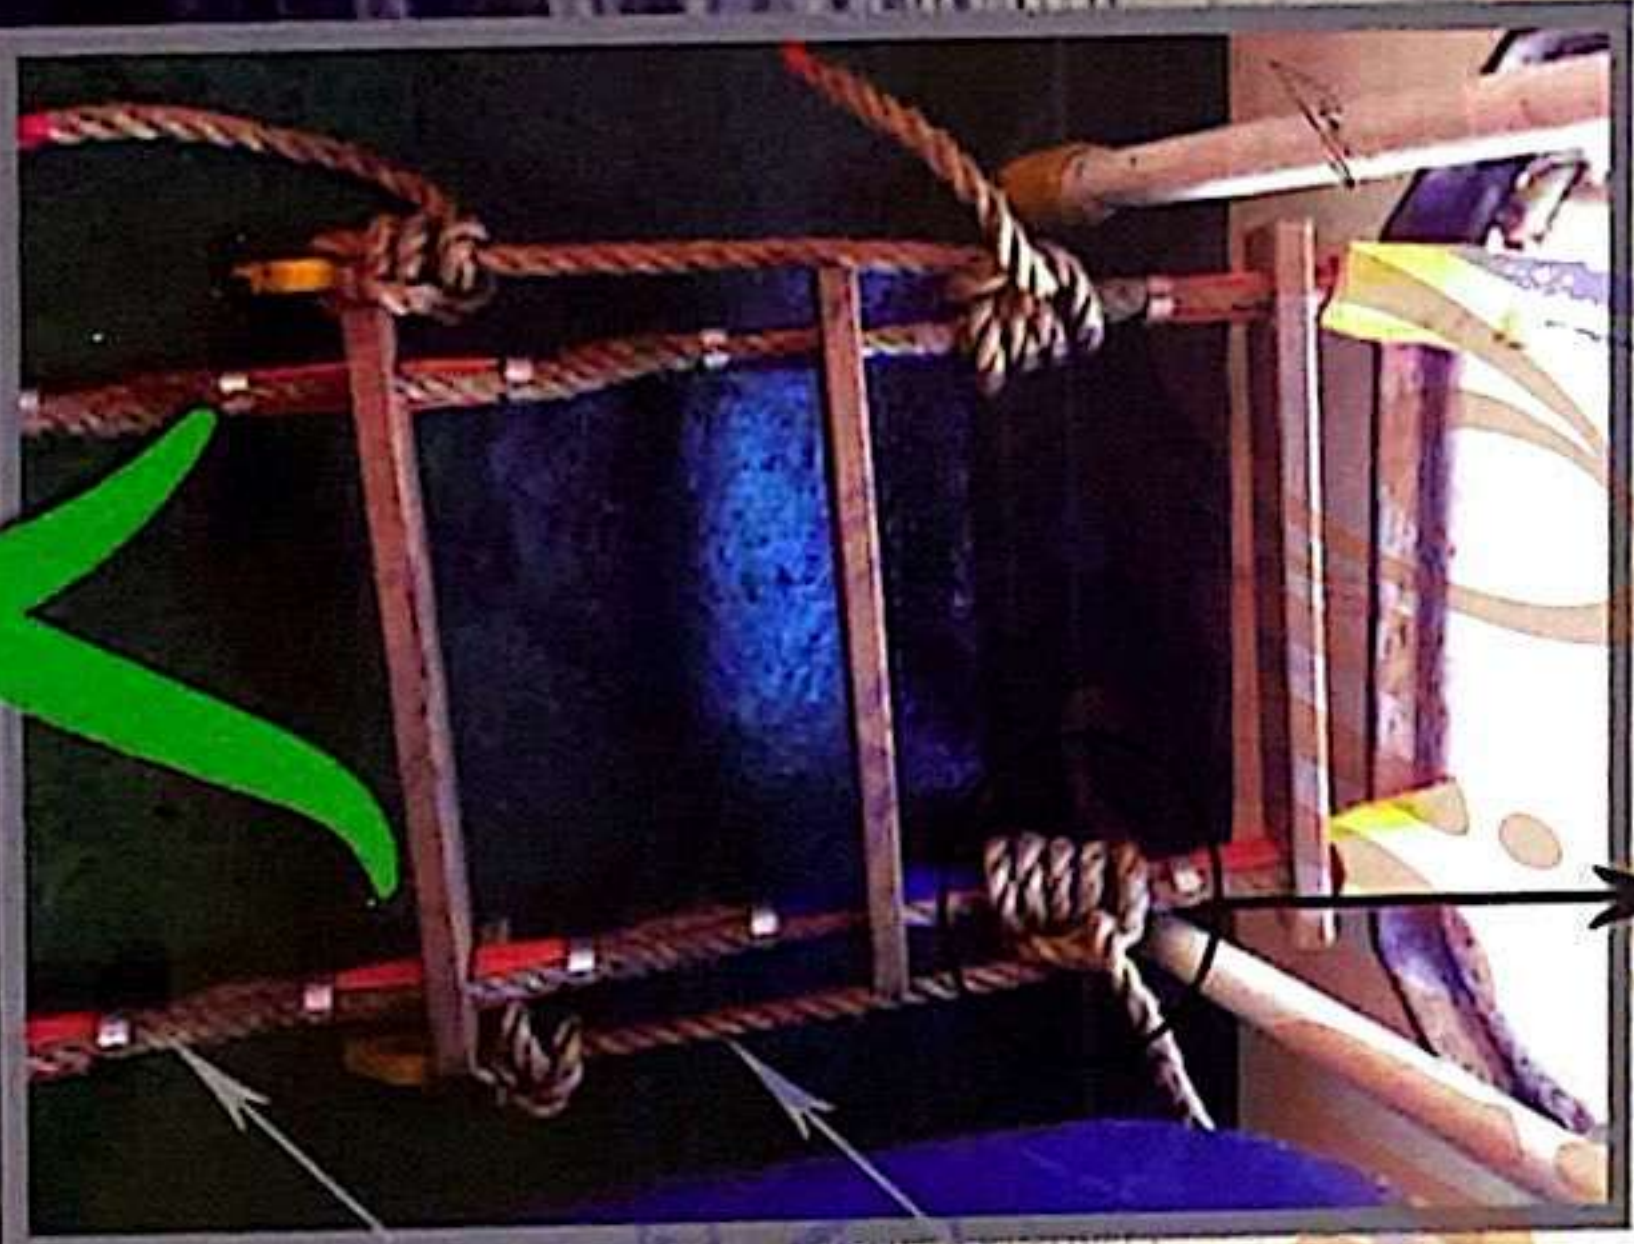
5.3 How to Rig a Pilot Ladder Correctly

MAKE SURE THAT ALL THE WEIGHT RESTS ON THE ROPES

MAKE SURE ALL STEPS ARE PARALLEL AND THE ROPES BETWEEN THEM STRAIGHT

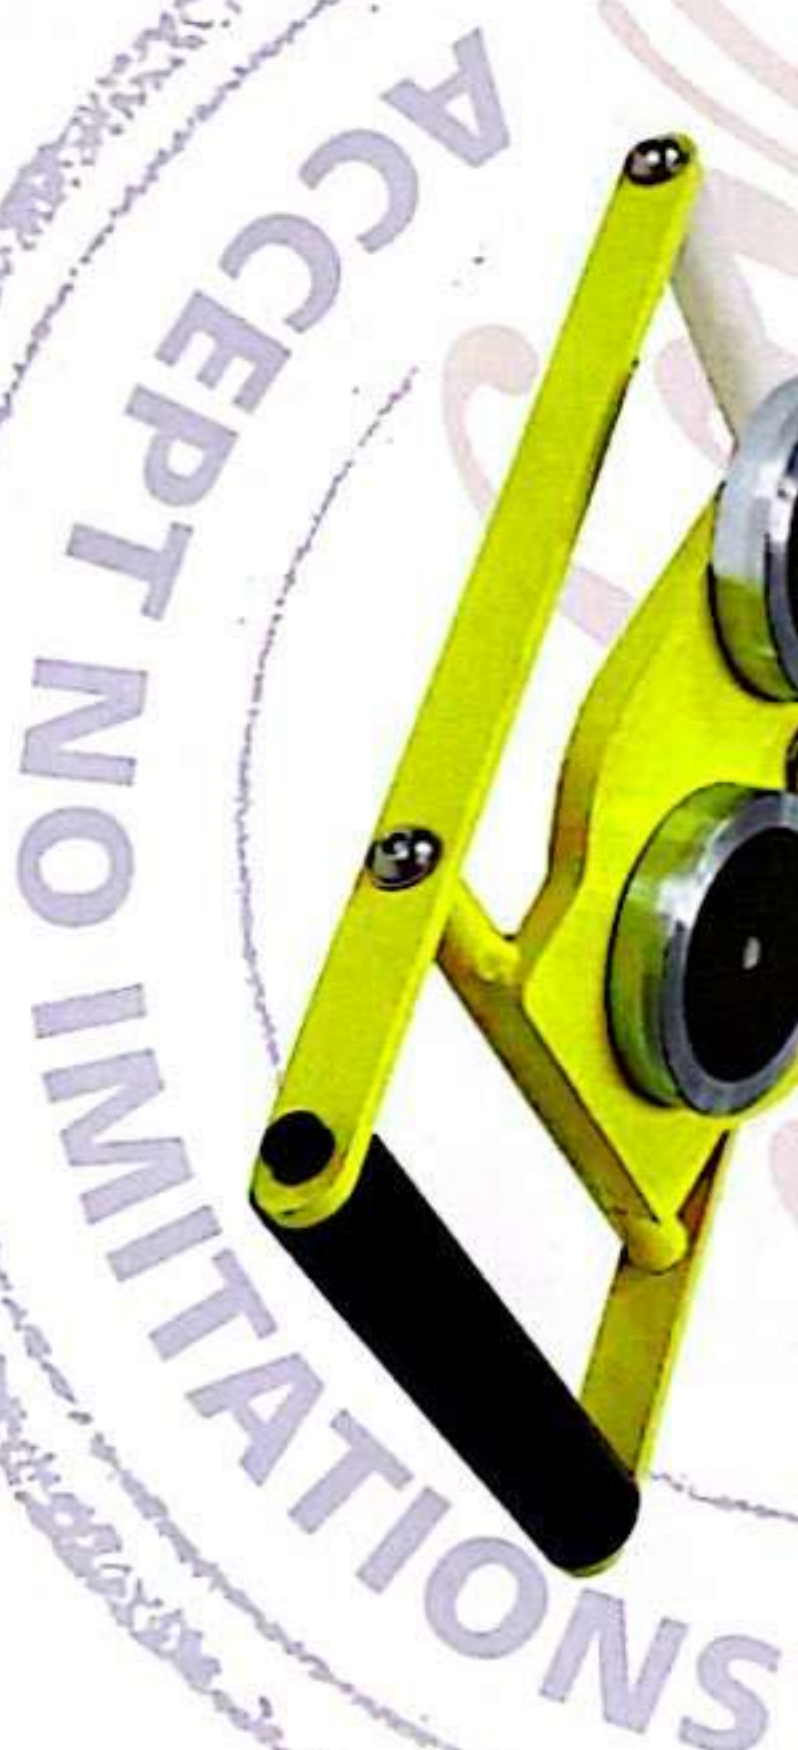
Examples acceptable Rigging for a Pilot Ladder

All PTRR Holland Magnetic Clamps Have a Holding Force >4.90kN
One per side rope as shown.

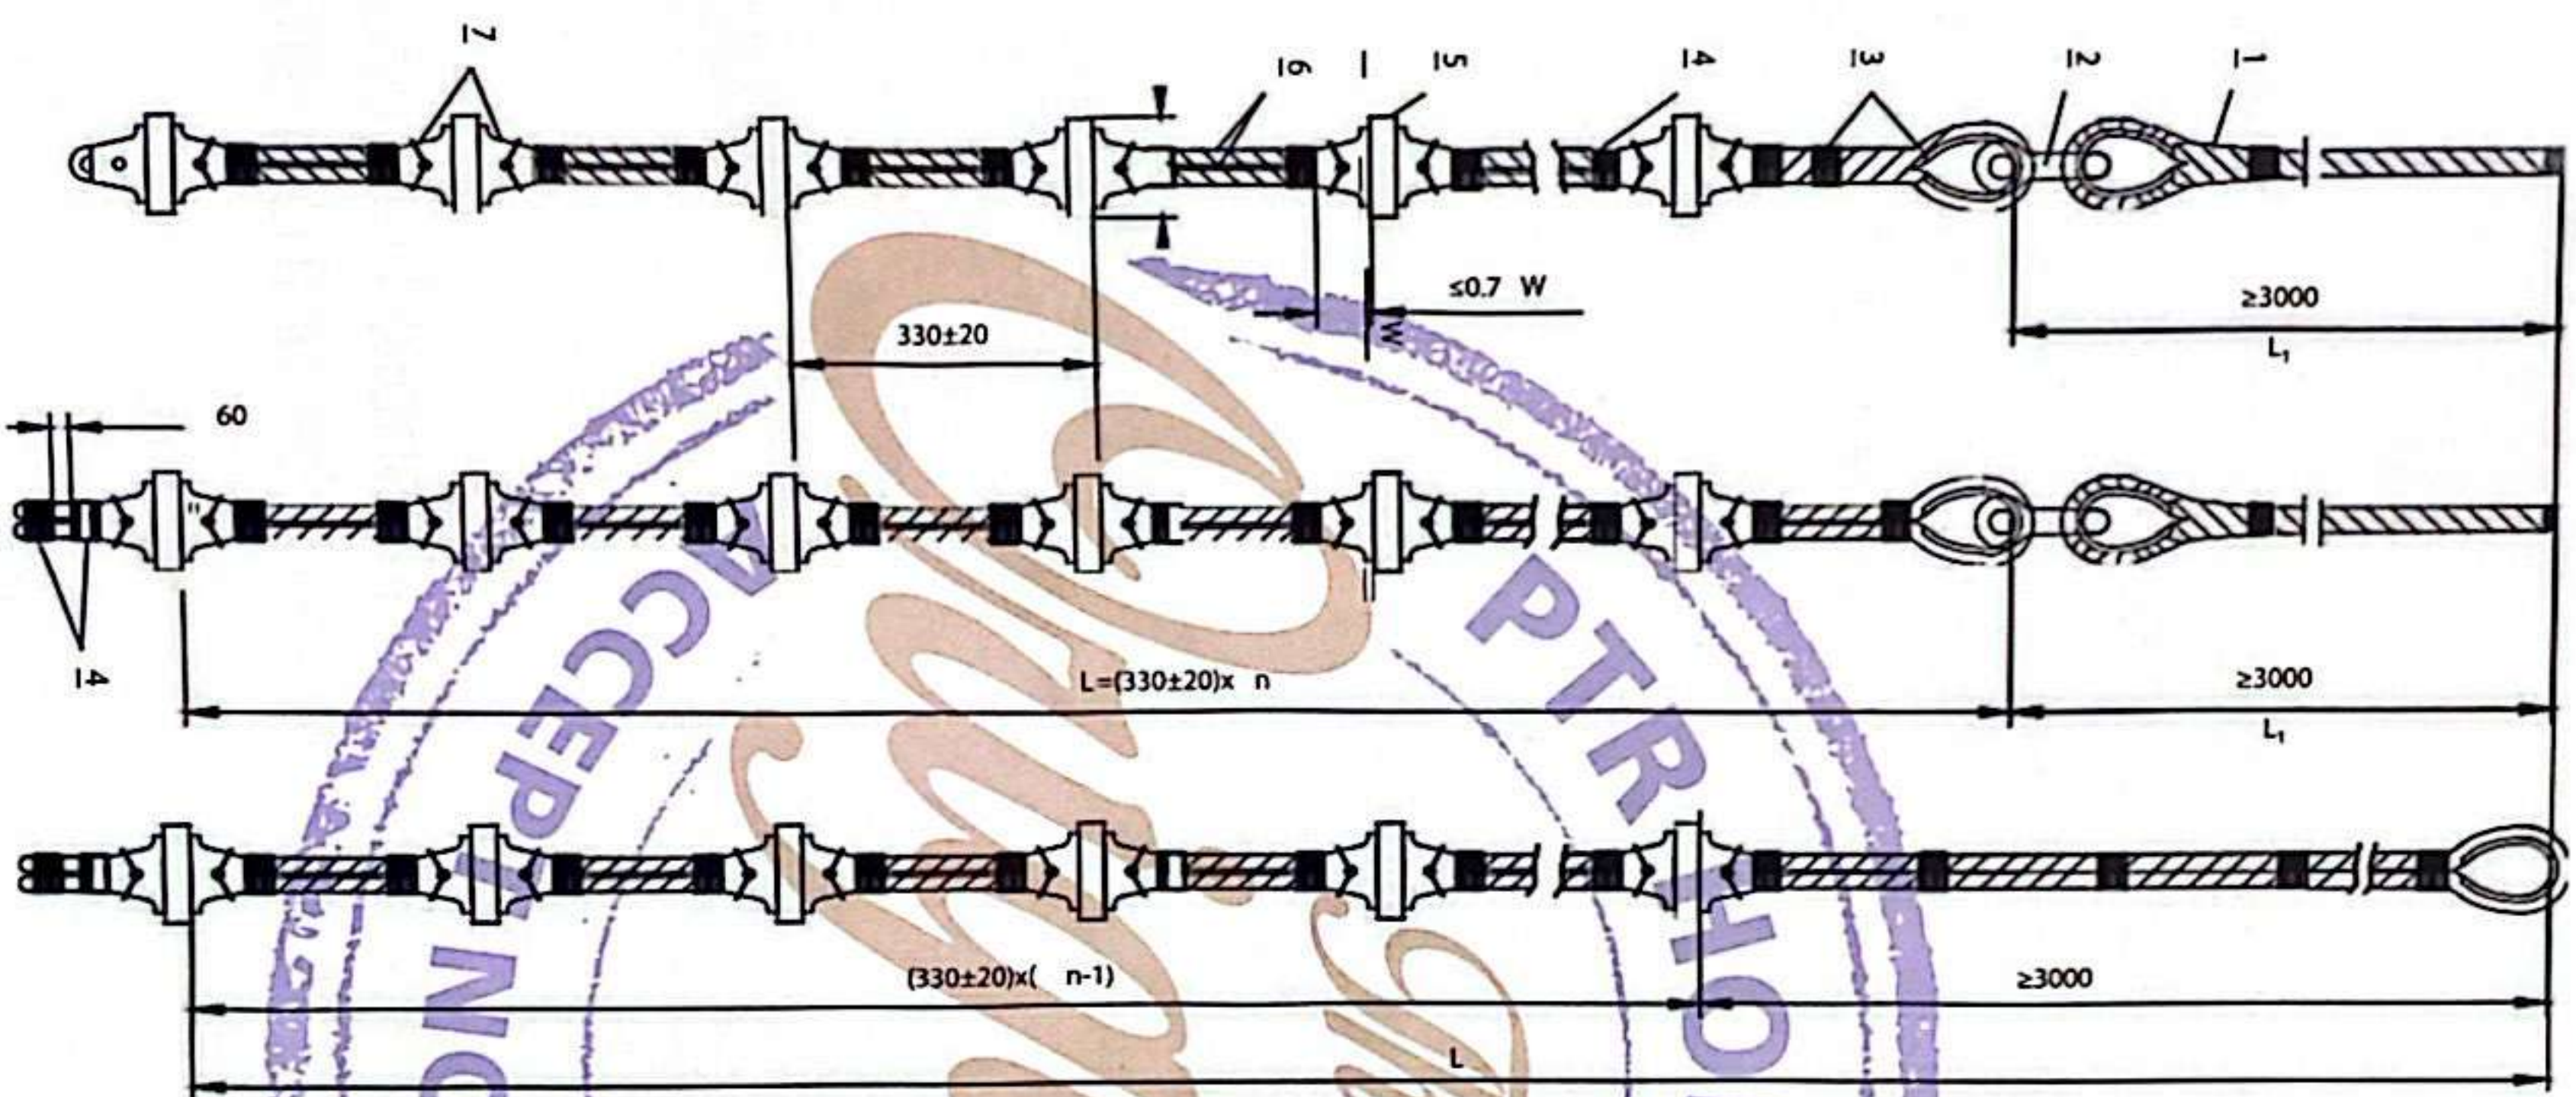
- 1 Securing Rope >48kn
- 2 Shackle
- 3 Splice/ Rope Seizing, Clamp
- 4 Rope Seizing (figure eight racking type)
- 5 Wooden Step
- 6 Side Rope
- 7 Plastic Fixture, Chock- Step Fixture

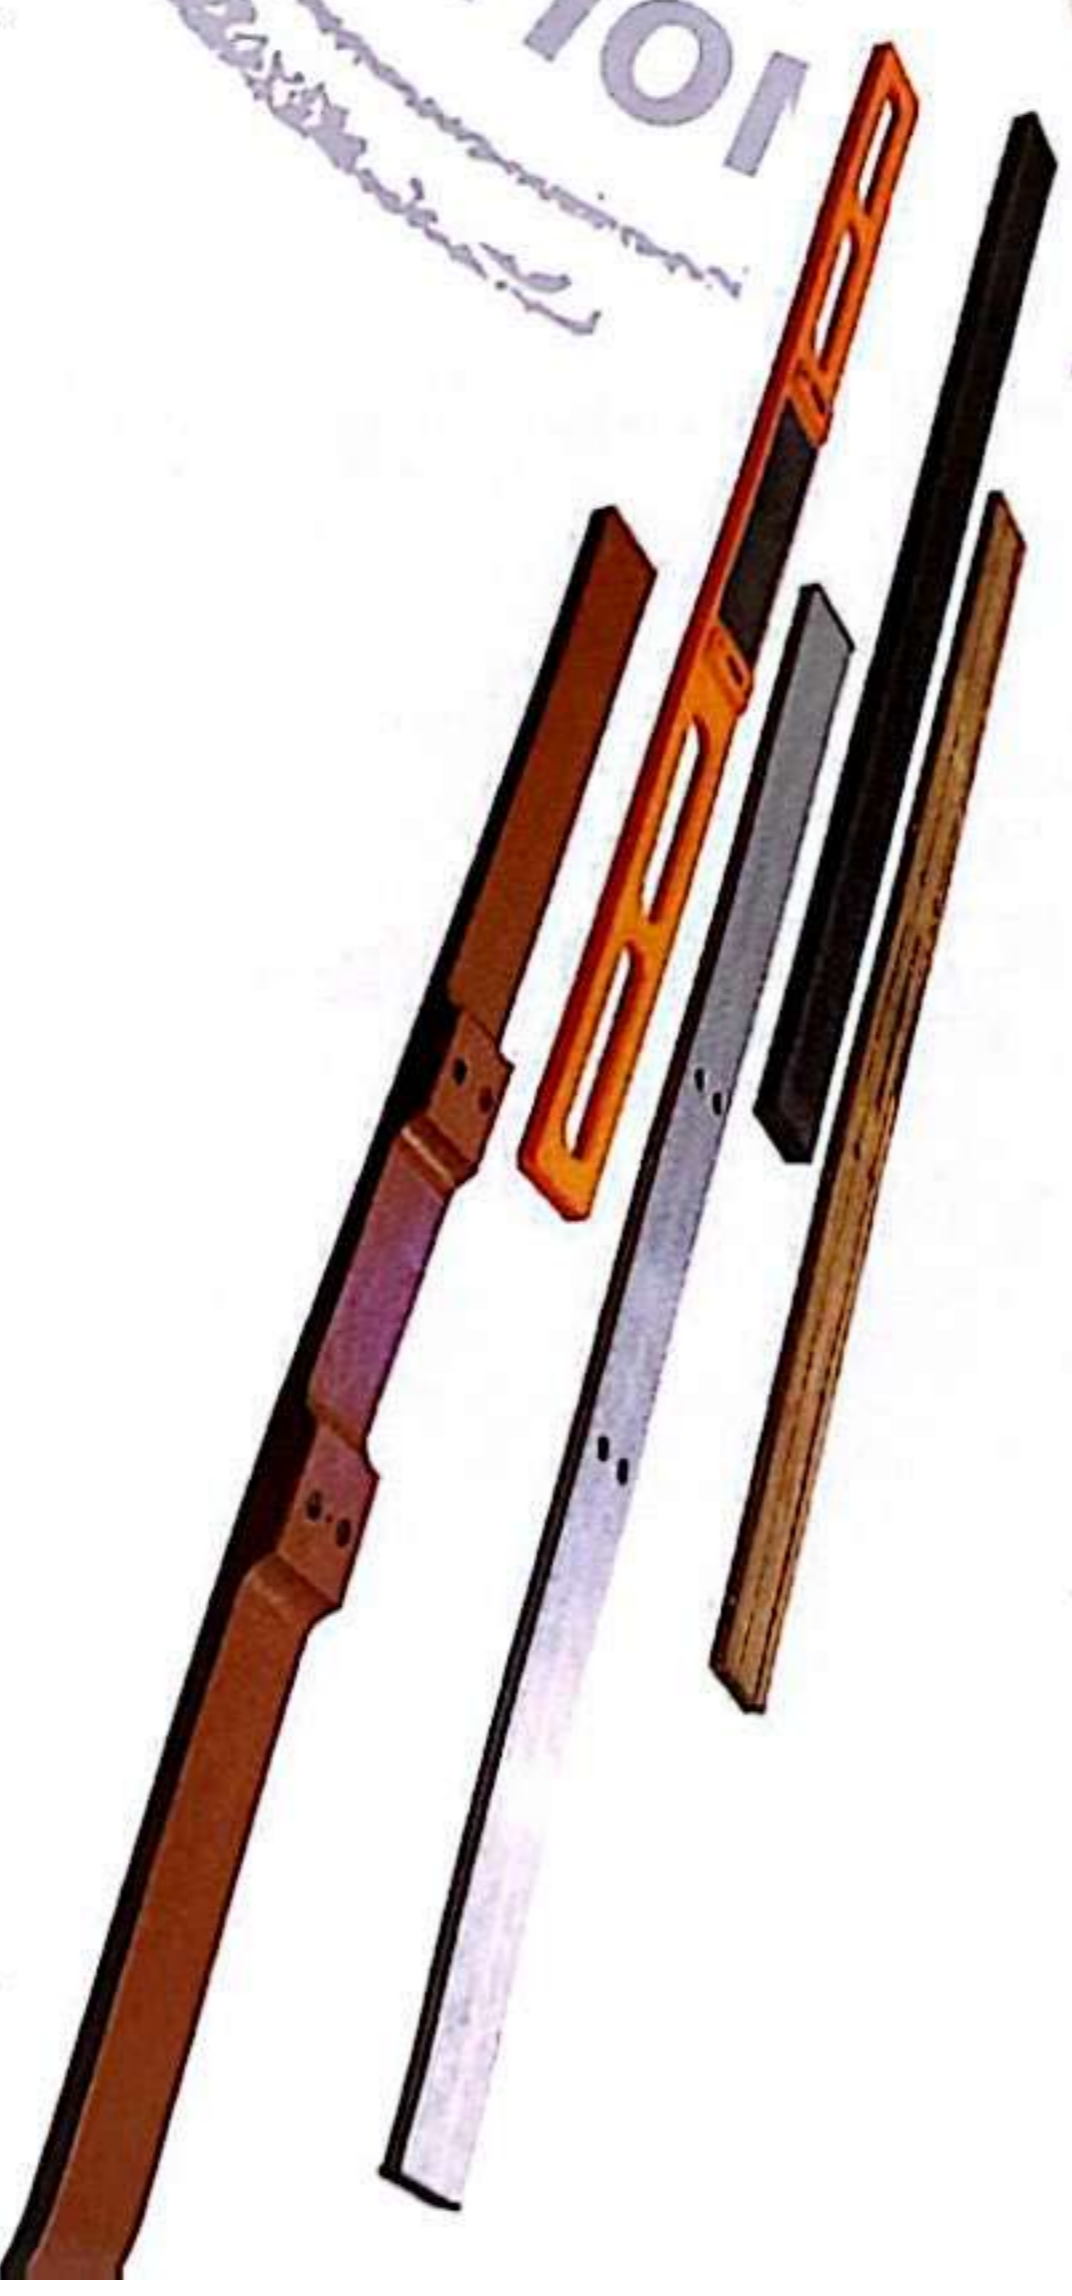
Replacement Procedure For Whippings

1. The damaged step or spreader should be carefully removed along with the whippings above and below the step. Every care should be taken not to damage the side ropes during this operation.

2. The replacement step/spreader should have the chokes placed on either side of the step where the cut outs are. Half of the choke one side of step and half the other side of step.

4. A figure 8 seizing of 3 ply tarred marlin should then be applied both above and below the winnet on both sides of the ladder to hold them tightly in place. The whipping should consist of a minimum 38mm length around both ropes and should be locked off with by means of a double frapping and finished off by passing between the side ropes.

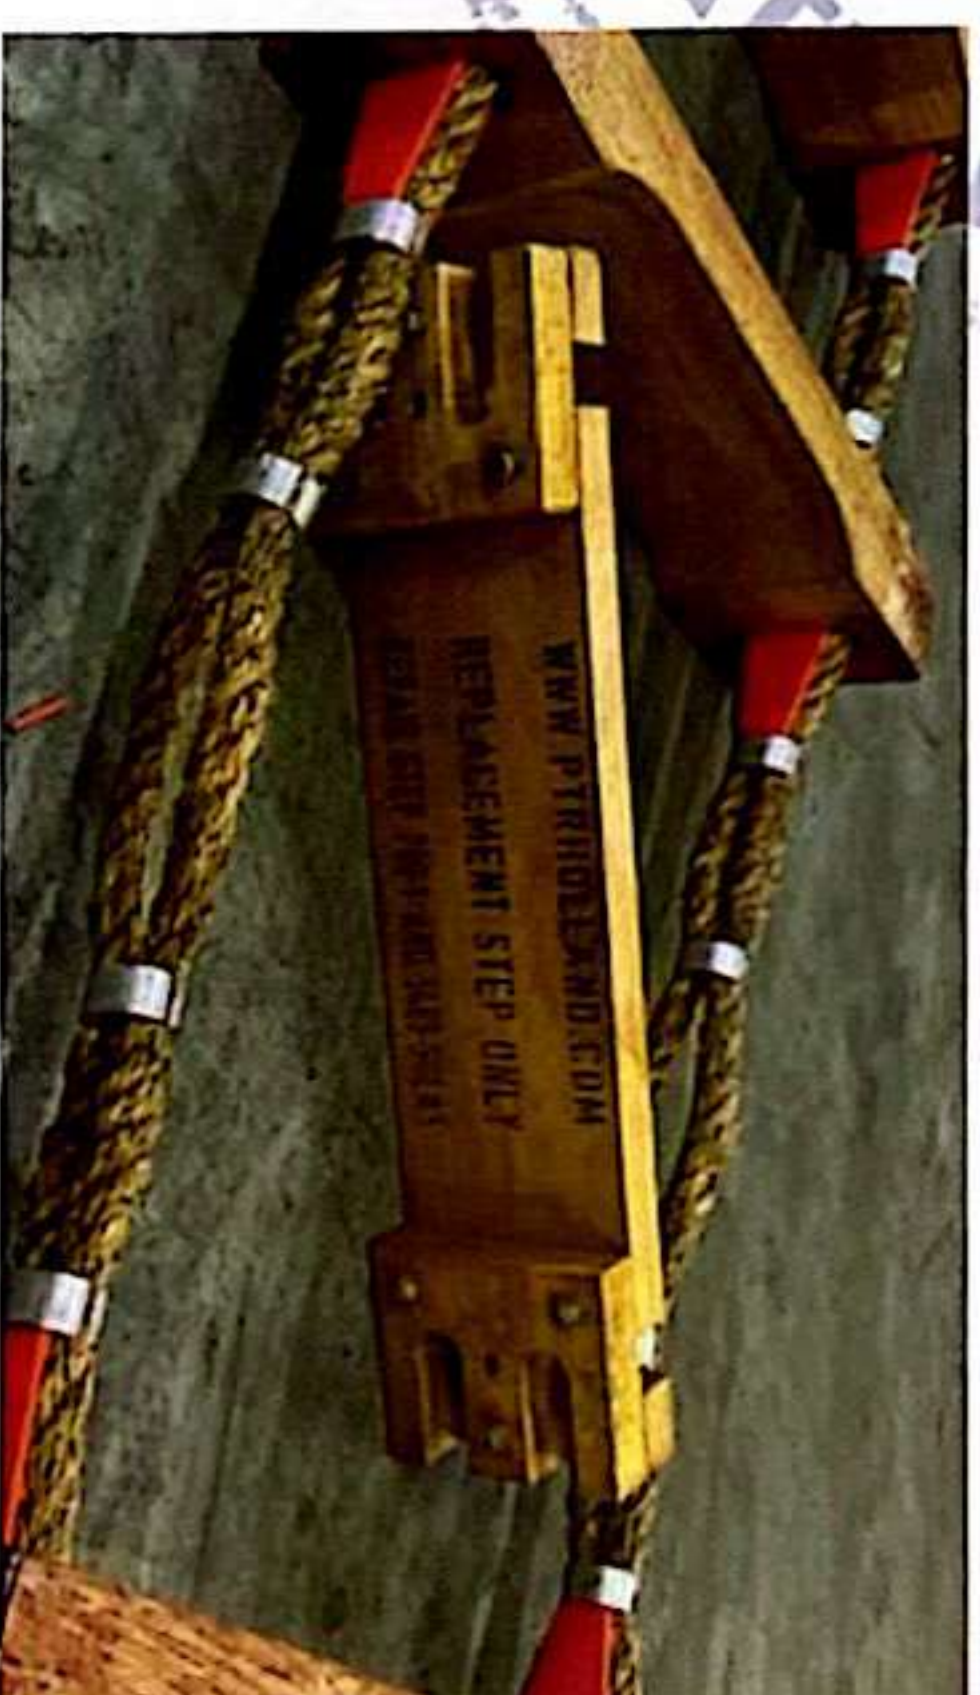
Replacement Procedure Metal Clamps

1. The damaged step or spreader should be carefully removed. Every care should be taken not to damage the side ropes and clamps during this operation.
2. The replacement step/spreader should then be slid into position with the grooves facing upwards between the 4 nylon chocks and set ready to take the nuts and bolts, these are tightened gradually securing the step in its new position.
